PORT OF HOOD RIVER COMMISSION
Tuesday, February 7, 2017
Marina Center Boardroom
5:00 P.M.

Regular Session Agenda

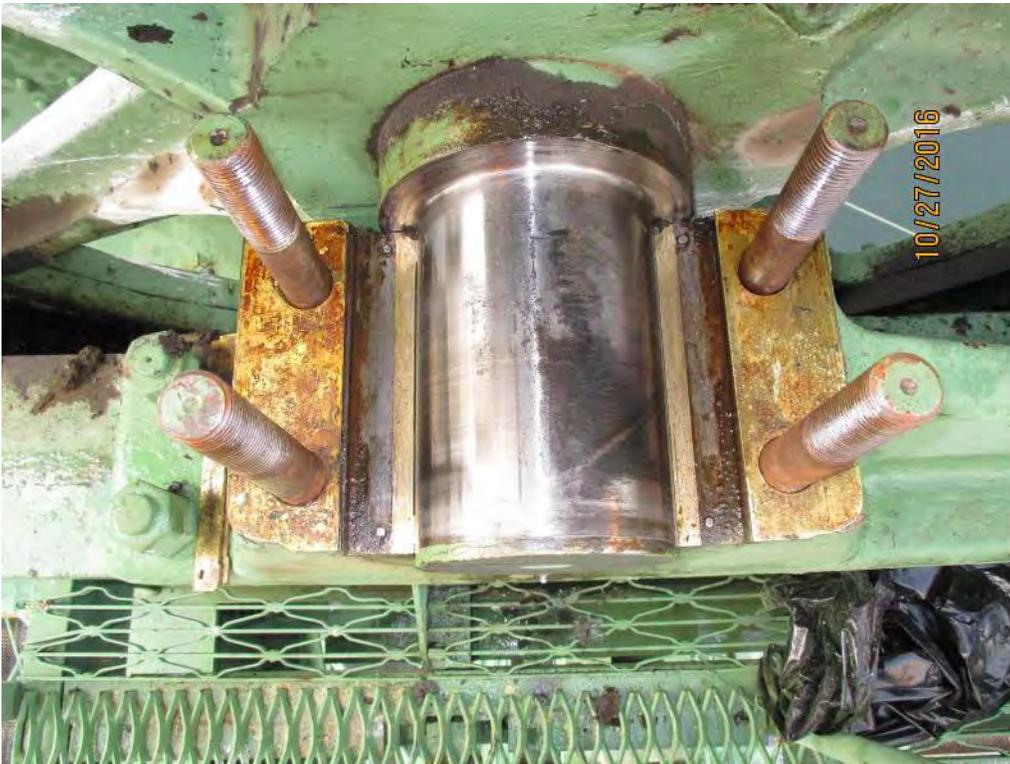
Photo 2 TB-NW-IB Journal. View with bearing cap removed and with the bridge raised for access to the portion of journal that is not visible with the bridge seated. Note the minor corrosion and dried lubricant.

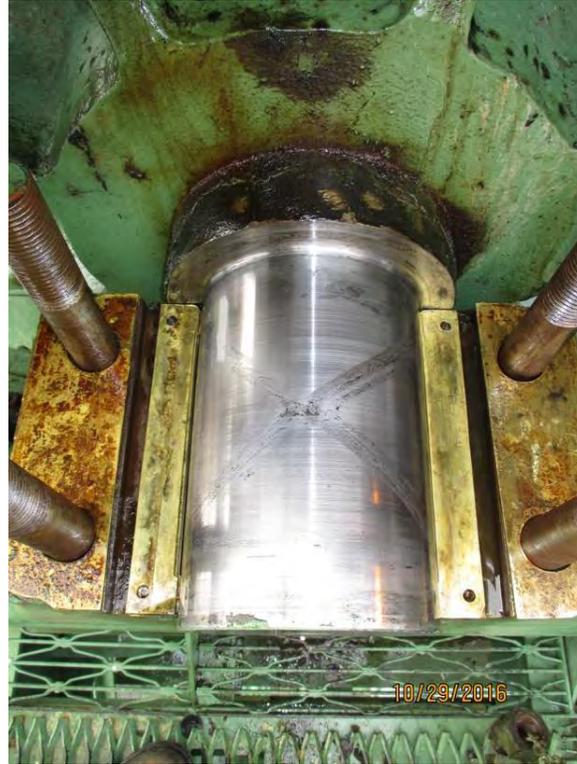
Photo 3 TB-NW-IB Journal. View of with bearing cap removed and with the bridge raised for access to the portion of the journal normally not accessible. This is a view after the removal of minor corrosion and dried lubricant.

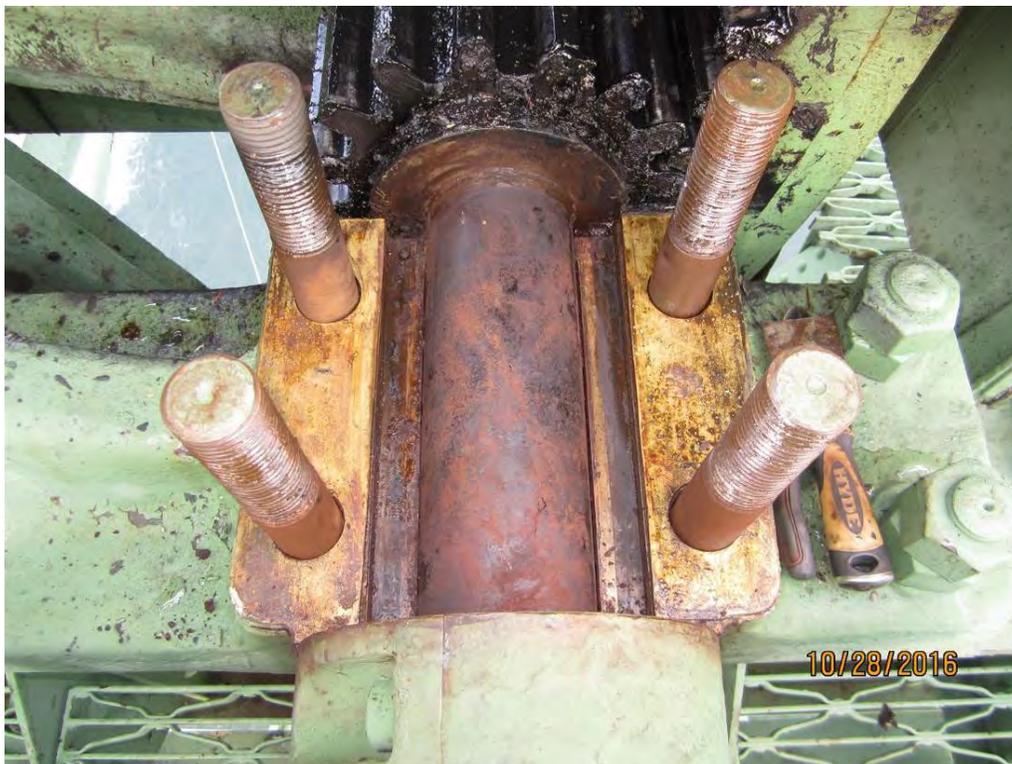
Photo 4 B1-NW Journal. View with bearing cap removed. The journal is in poor condition with heavy corrosion and minimal lubricant.

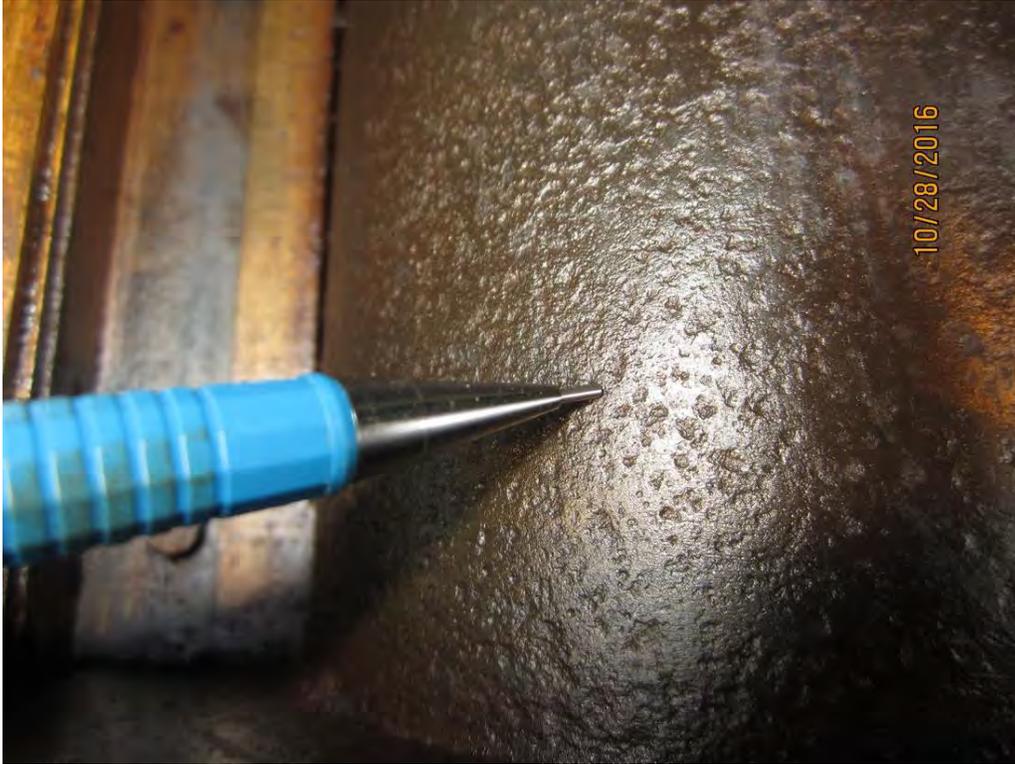
Photo 5 B1-NW Journal. Close-up view of Photo 4. Note the corrosive pitting on the journal.

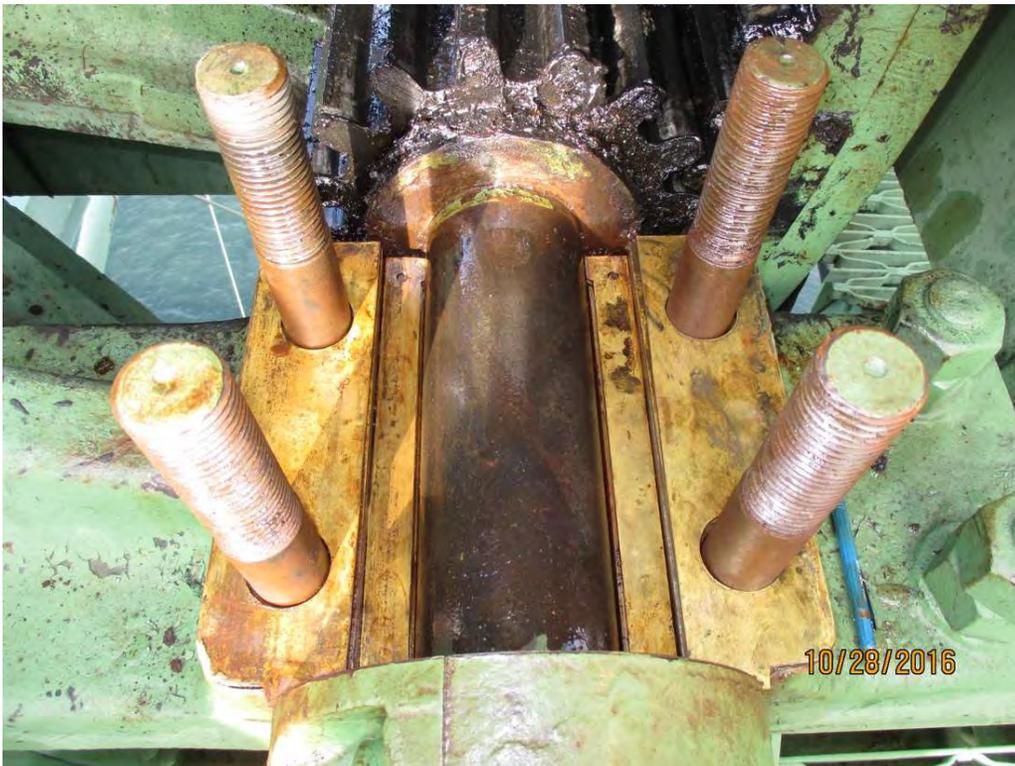
Photo 6 B1-NW Journal. View prior to re-assembly. The journal has been hand-dressed with emery cloth and fresh lubricant has been applied.

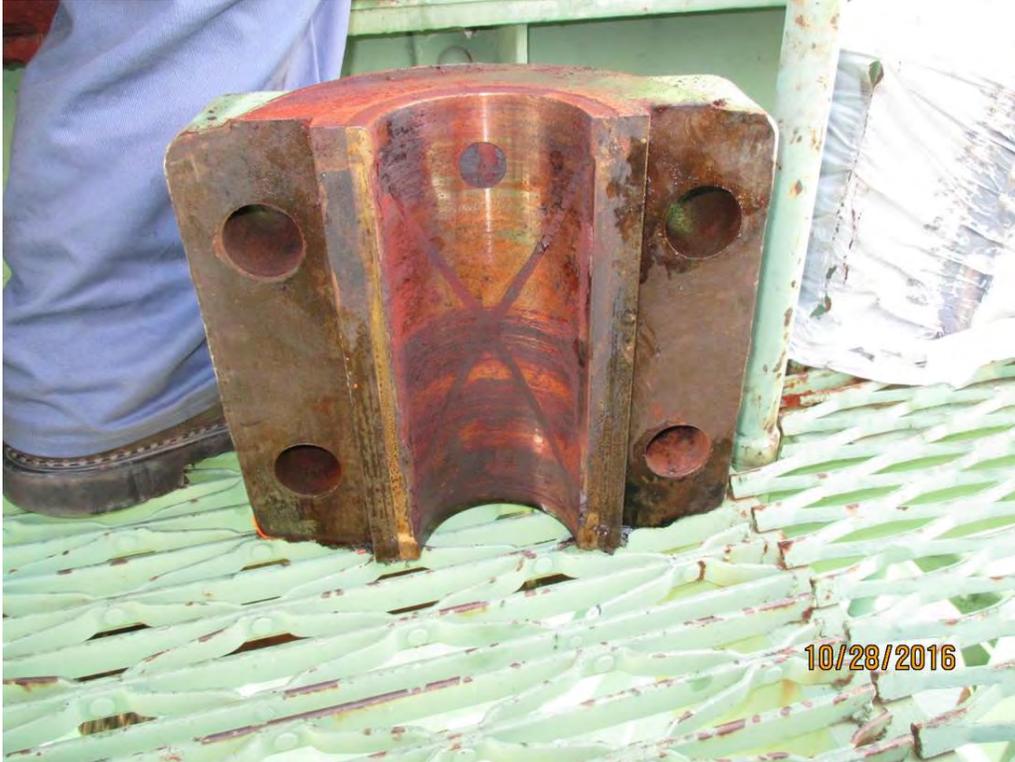
Photo 7 B1-SW Cap. View of cap prior to cleaning. Note the fretting corrosion and the clogged lubrication ports.

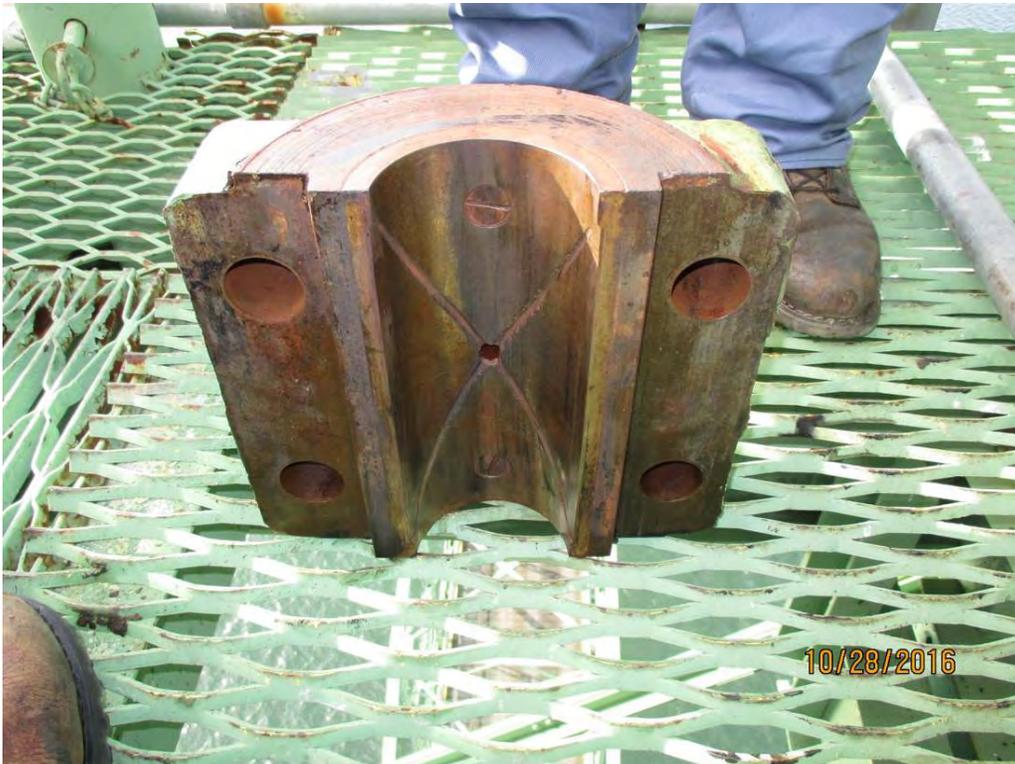
Photo 8 B1-NW Cap. View of cap after cleaning. The lubrication ports have been cleared and fretting and old lubricant have been removed.

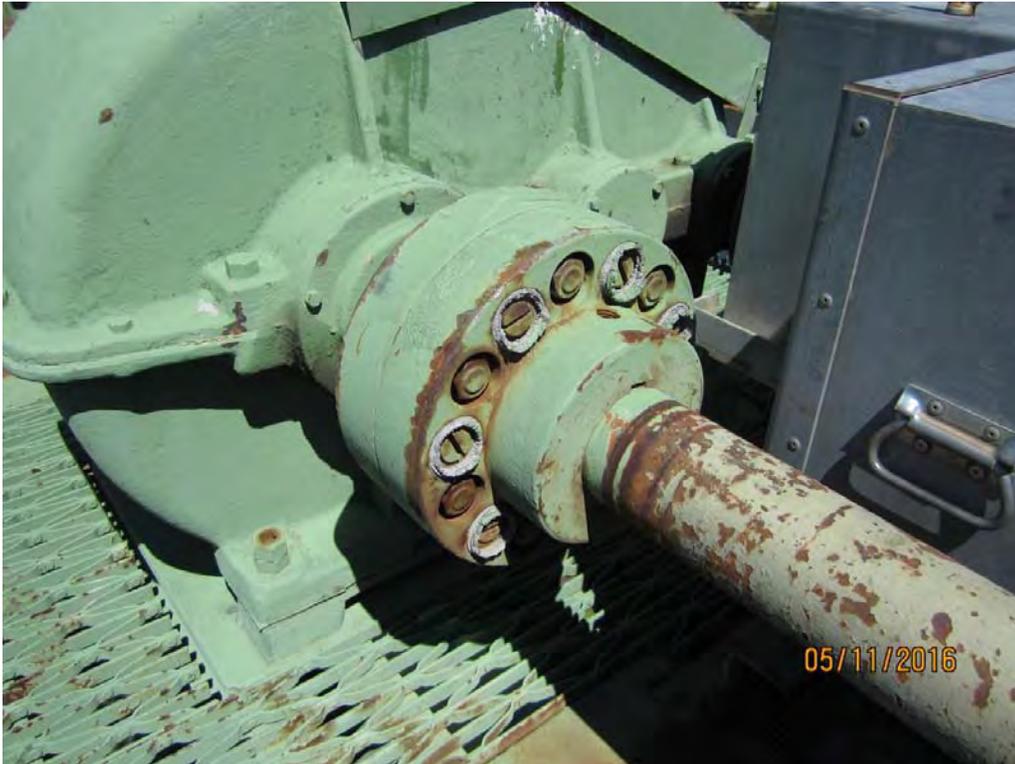
Photo 13 Rack Pinion Shaft Coupling. The coupling transmits torque via a bolt/pin installed with an elastomeric material through the coupling hubs. The elastomeric material is deformed and degraded.

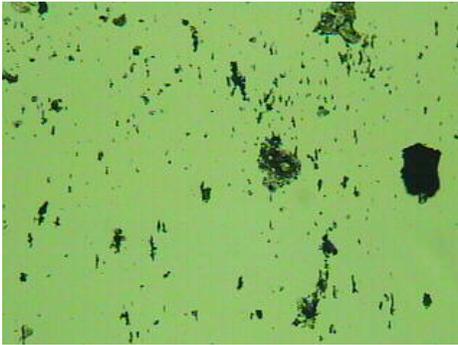
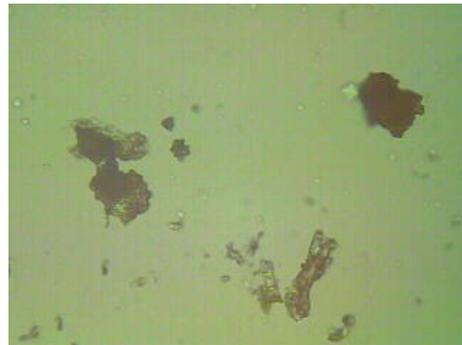
PHOTO-MICROGRAPH A @ 100 X
 Overview of the slide entrance. This slide appears predominantly occupied with large siliceous debris, friction polymers, lacquers and various chunks of red oxides.

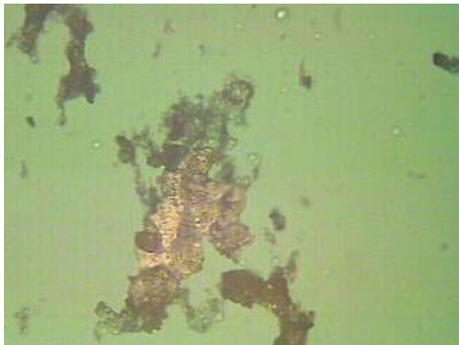
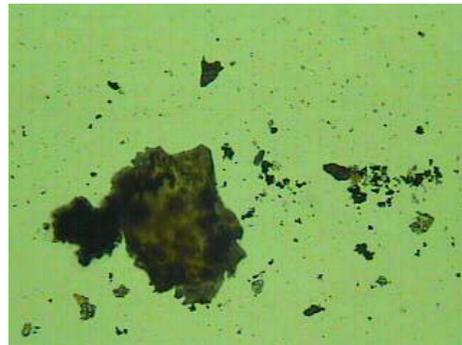
PHOTO-MICROGRAPH C @ 100 X
 This bright yellow metal platelet appears to resemble a 3-body gear wear particle with undefined circumference, rough edges and striated marks. It is at least 20 microns large.

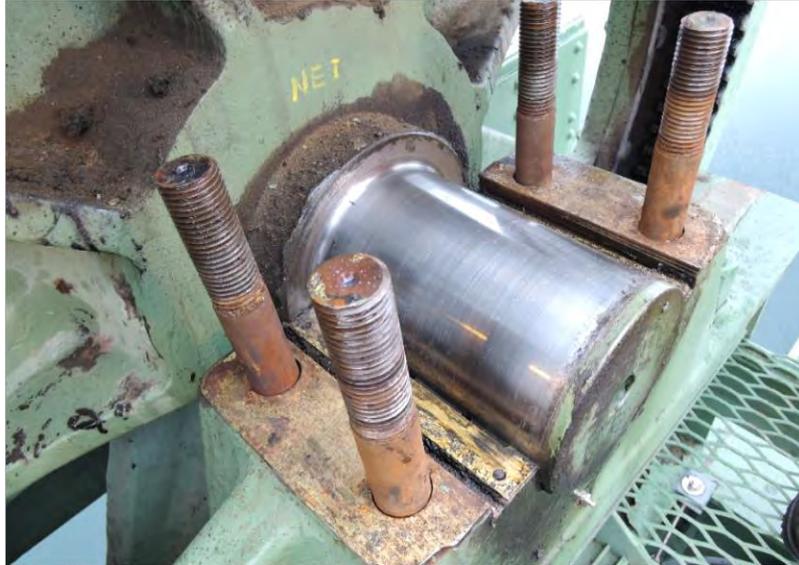
Figure 7. The northeast inboard trunnion journal exhibited nearly negligible wear of the journal surface.

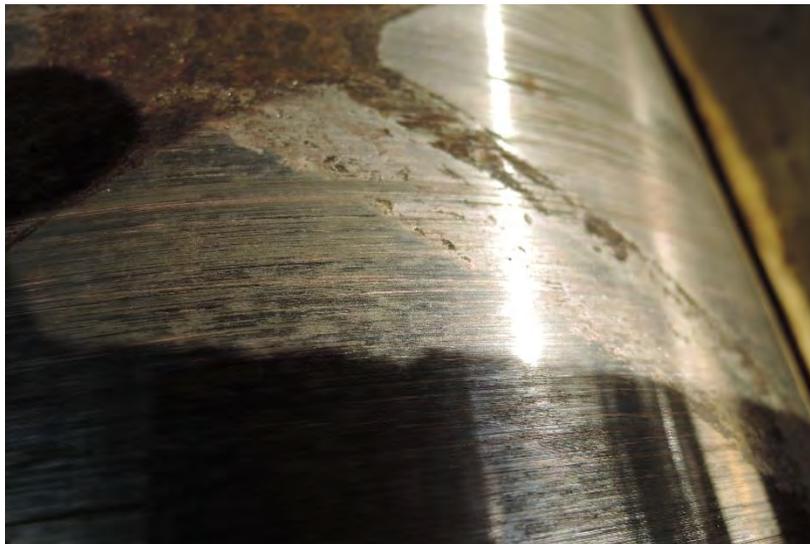
Figure 8. Bronze embedment as shown at the inboard journal surface of the southeast trunnion is indicative of insufficient lubrication.

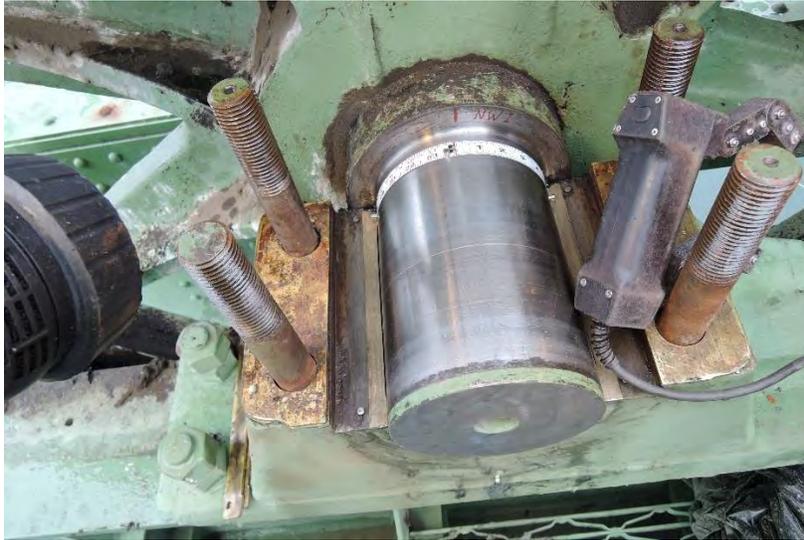
Figure 9. Minor scoring was observed near the middle of the northwest trunnion journal.

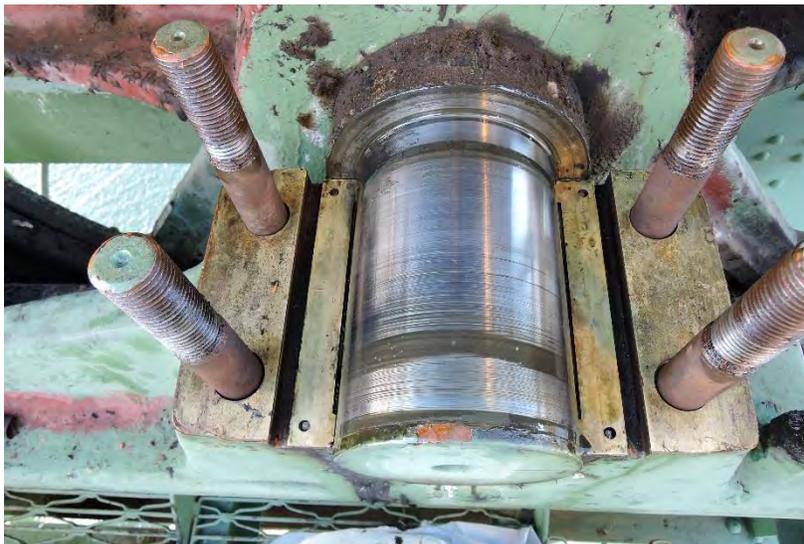
Figure 10. Moderate scoring was evident in the inboard journal of the southwest trunnion.

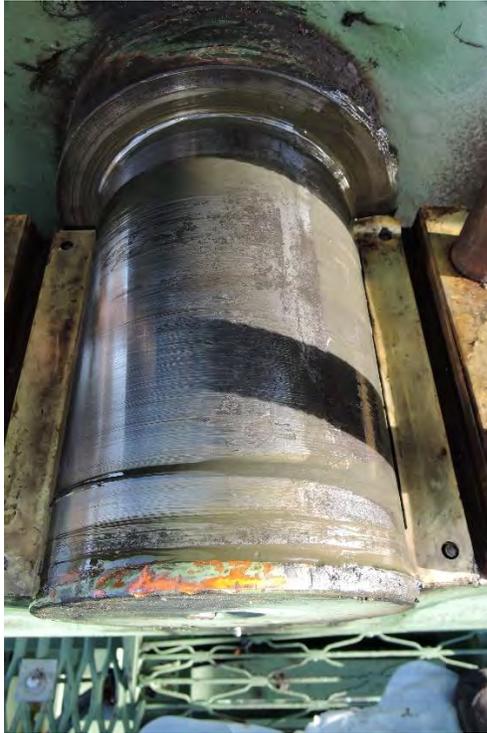
Figure 11. Corrosion pitting of the inboard journal of the southwest trunnion was indicative of contaminants within the bearing lubrication.

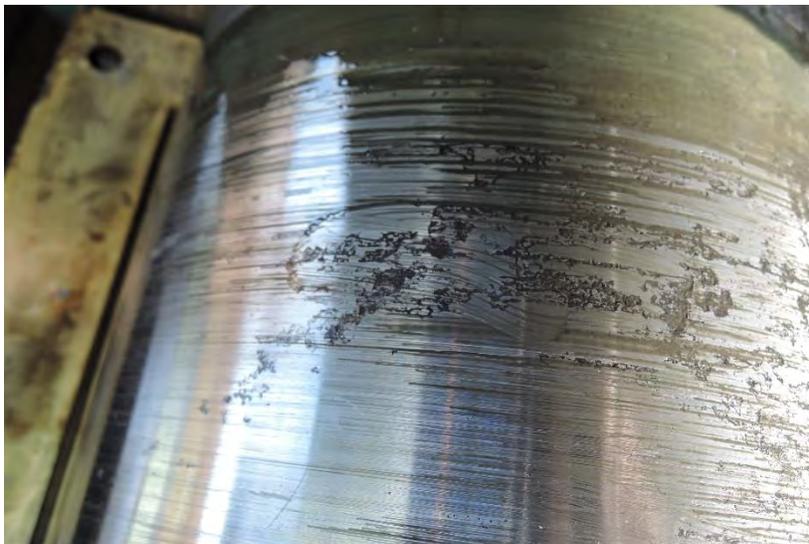
Figure 12. Pitting of journal surfaces is mostly local and shallow as shown in the inboard journal of the southwest trunnion.

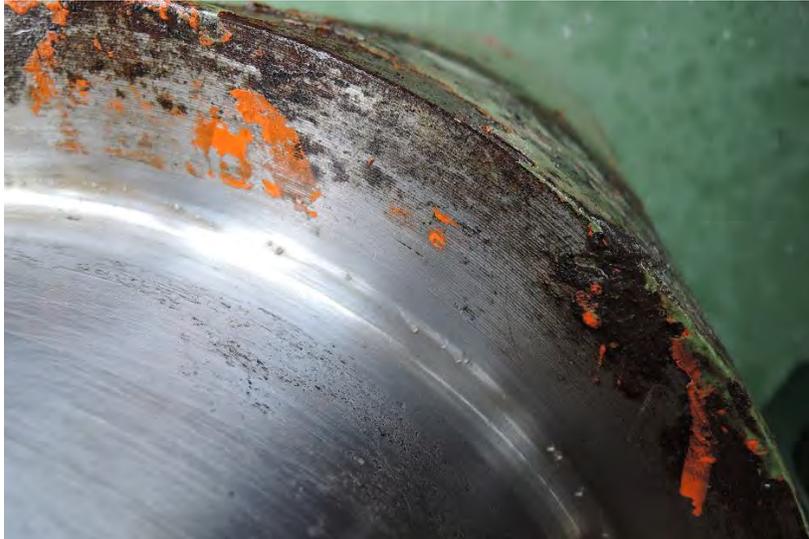
Figure 13. A series of small gouges was observed through much of the circumference within the mid to high portion of the fillet region at the outboard journal of the southwest trunnion.

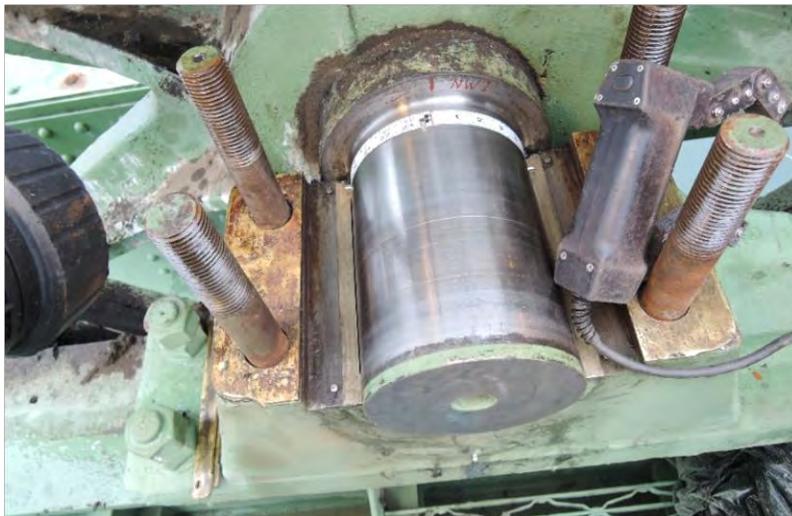
Figure 14. Magnetic particle examination was applied at the transitional region of the trunnions.

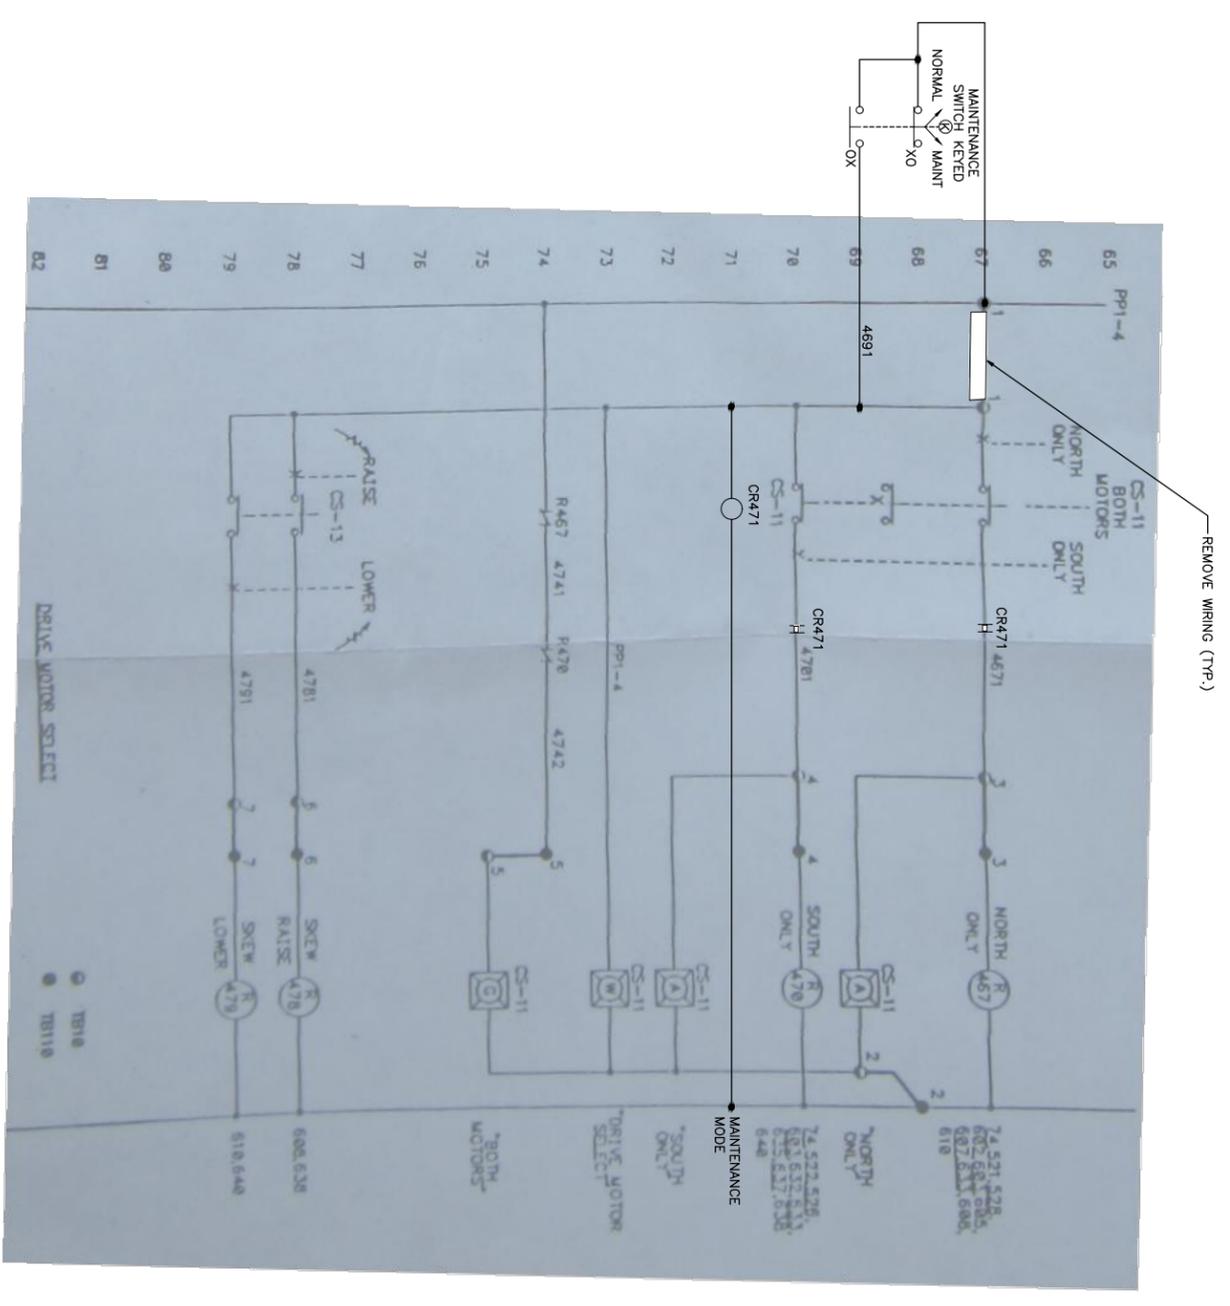
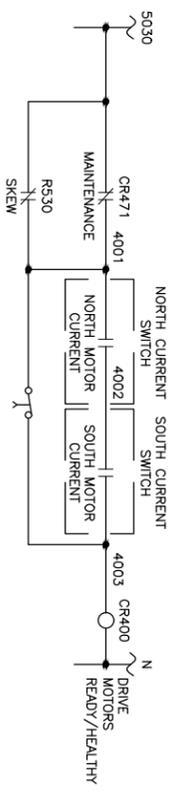
- NOTES:
1. ADDED A KEY OPERATED MAINTENANCE SWITCH
 - a. NORMAL POSITION WILL ONLY ALLOW BOTH MOTORS TO BE SELECTED FOR OPERATION.
 - b. IN MAINTENANCE MODE, THE QUALIFIED MAINTAINER CAN SELECT TO OPERATE NORTH, SOUTH OR BOTH DRIVE MOTORS USED FOR TROUBLESHOOTING, TESTING OR ULTIMATE SKEW ELIMINATION.
 2. ADDED COMPONENTS:
 - a. KEY OPERATED TWO-POSITION TWO POLE SWITCH
 - b. AB RELAY (700-P400A1)

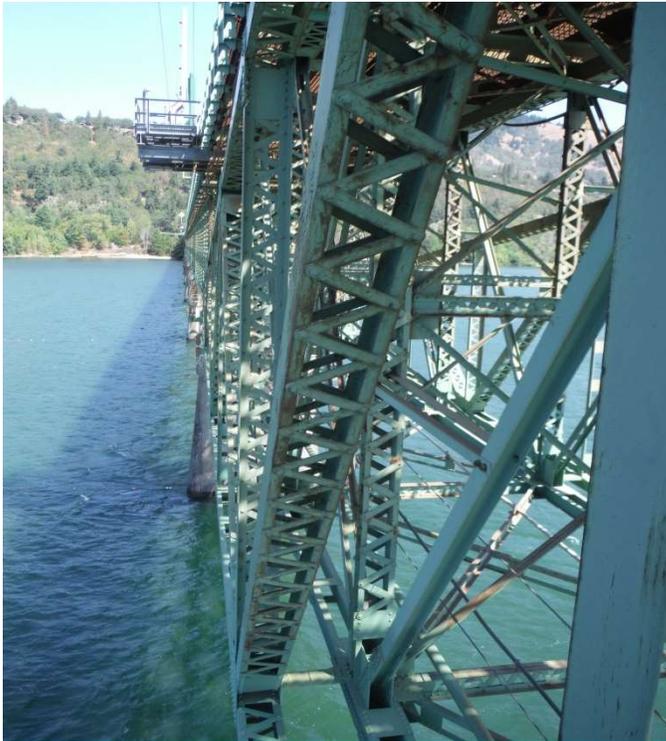
Hood River-White Salmon Interstate Bridge Seismic Vulnerability Assessment

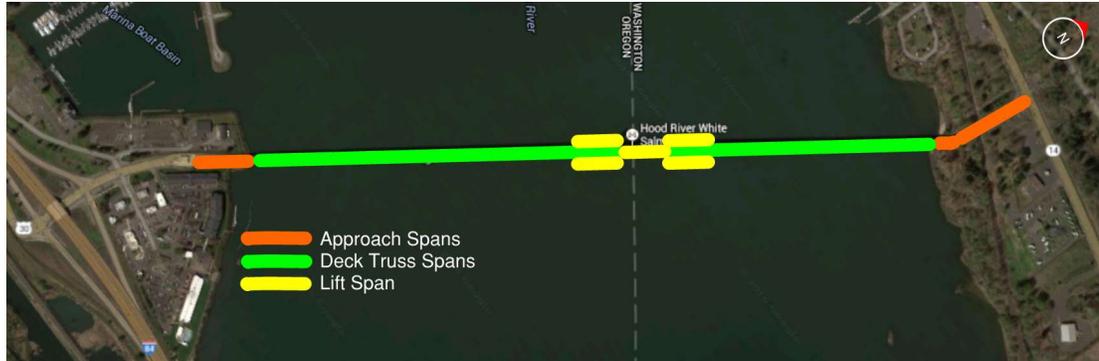
Figure 3-1. Bridge Segments for Discussion of Seismic Vulnerability

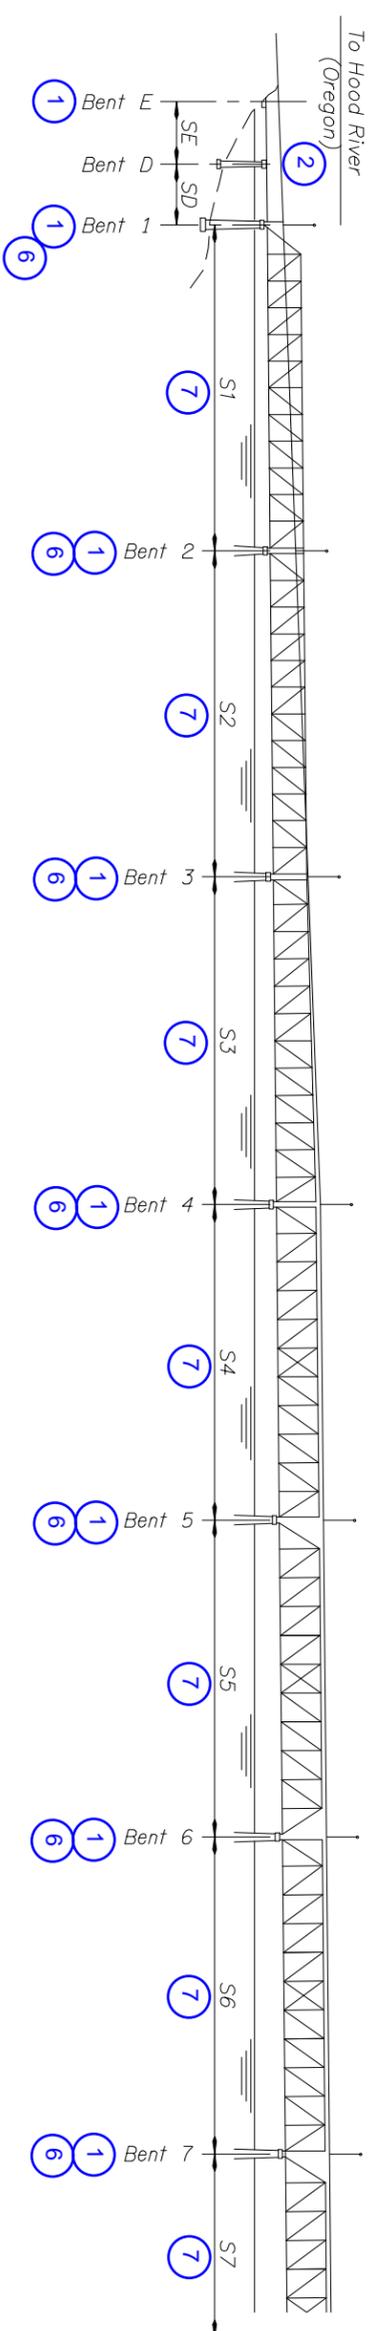
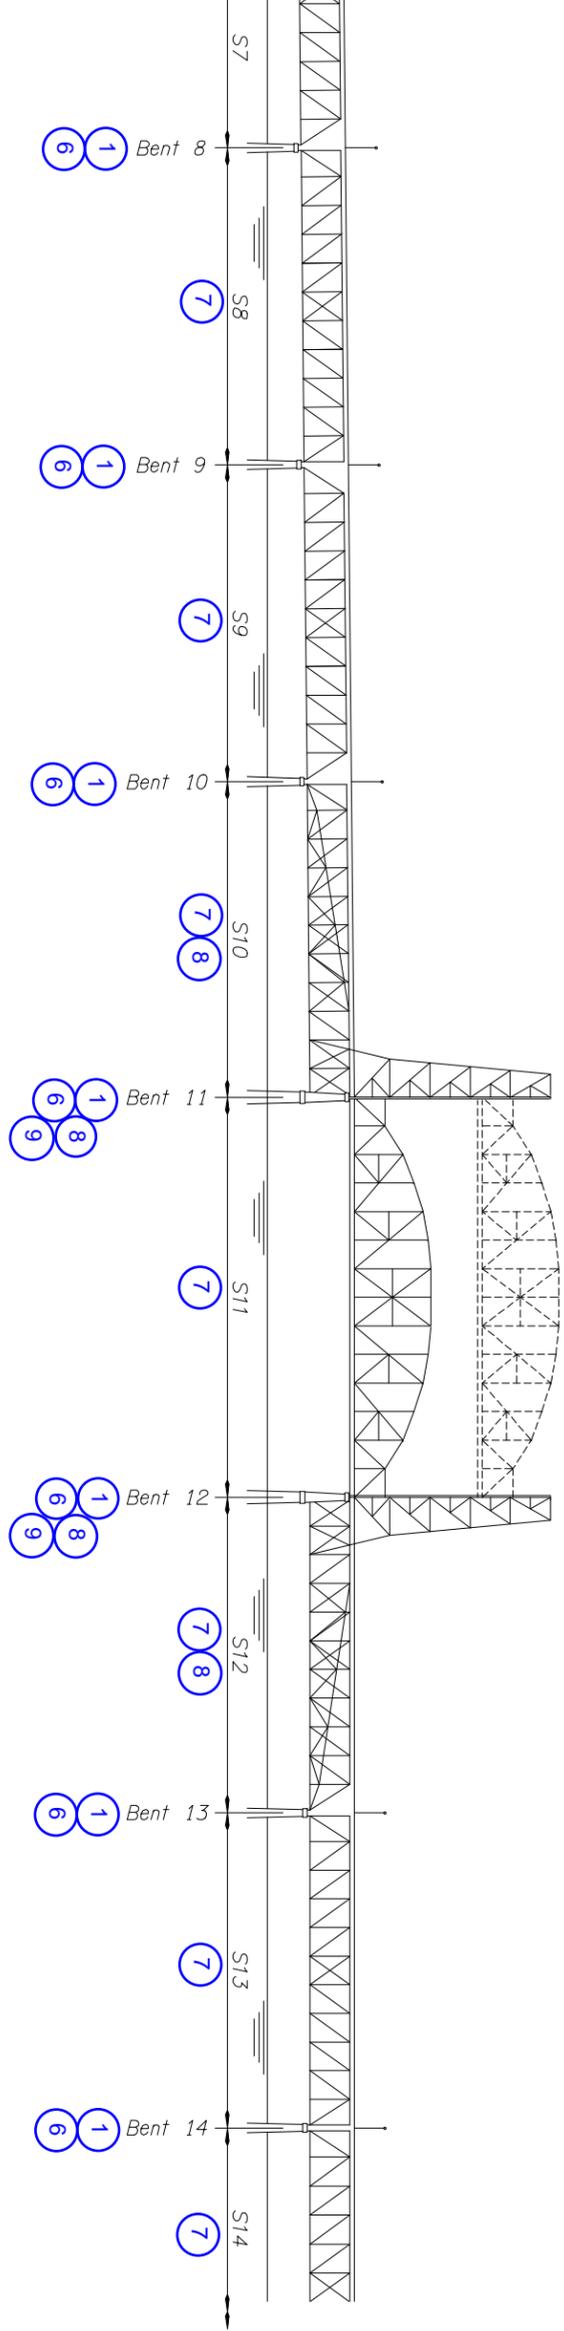
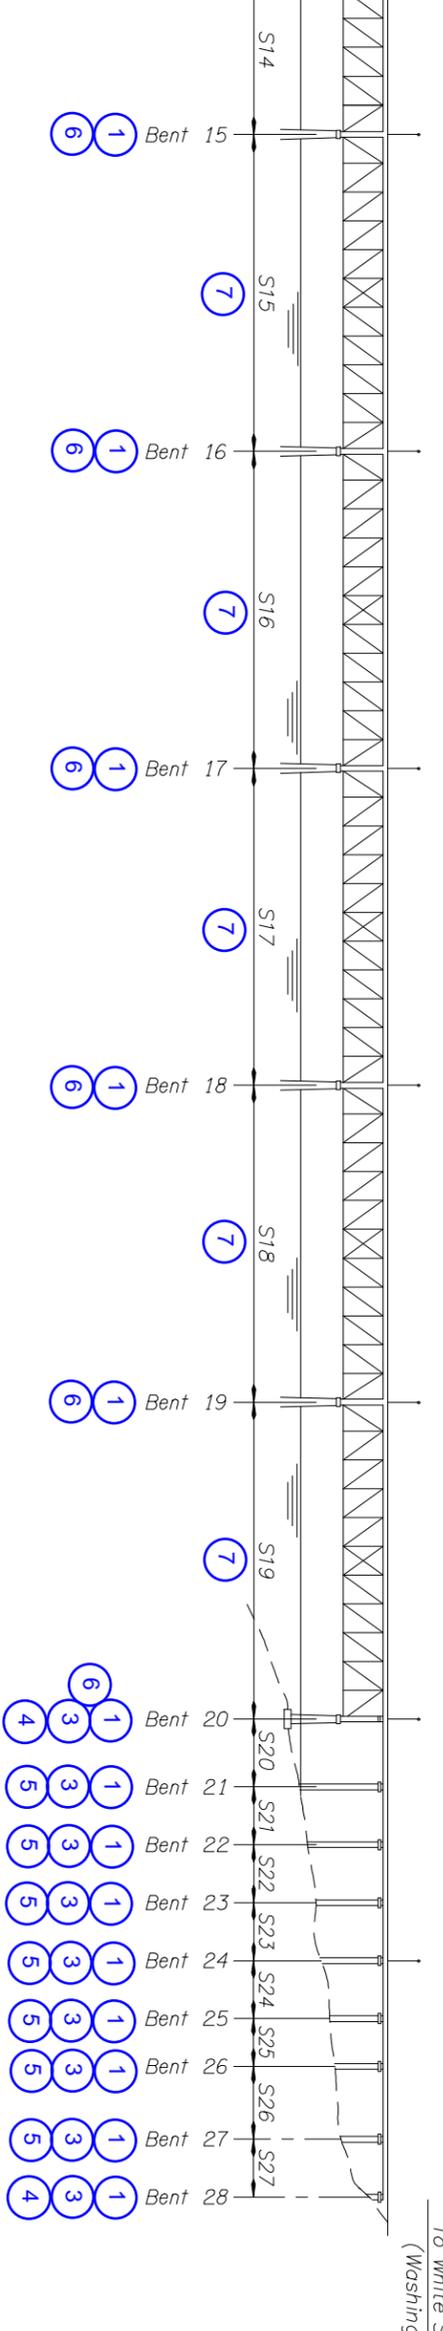
- Phase 1 Seismic Retrofit Legend**
- 1 Enlarge seat/add shear lugs
 - 2 Replace with one span
 - 3 Allow dowel fuse
 - 4 Strengthen end diaphragm
 - 5 Strengthen crossbeams
 - 6 Replace steel bearings
 - 7 Strengthen truss members & connections
 - 8 Strengthen tower members & connections
 - 9 Secure mechanical equipment
