HOOD RIVER - WHITE SALMON INTERSTATE BRIDGE

STRUCTURAL CONSIDERATIONS FOR
PEDESTRIAN CROSSING ON THE EXISTING
BRIDGE

October 12, 2012

HNTB Corporation
111 SW Columbia Street, Suite 940
Portland, Oregon 97201

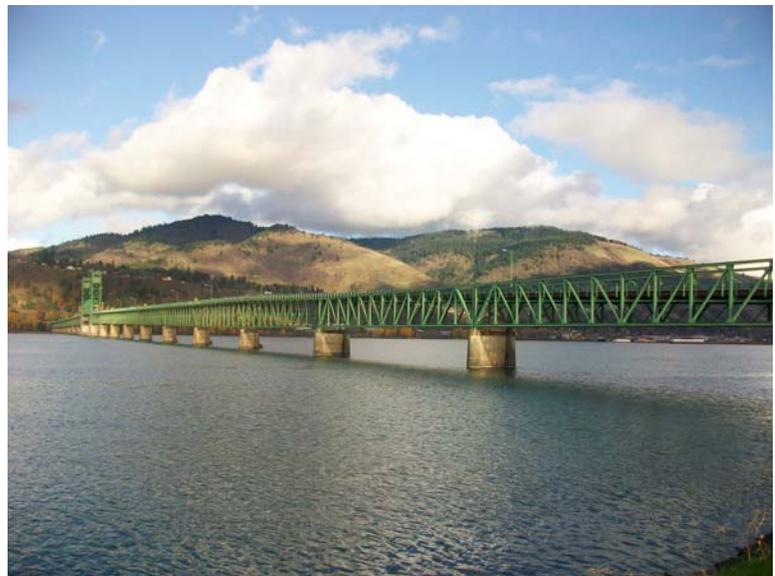
Figure 1. Hood River–White Salmon Interstate (Columbia River) Bridge as seen from the Oregon bank

The bridge is a long, very narrow, two-lane, steel deck truss with a vertical lift span near the middle of the bridge, as seen in Figure 1. The bridge is owned, operated, and maintained by the Port. Currently the bridge is not suitable for safe ped/bike traffic. The bridge is an important transportation link connecting the States of Oregon and Washington across the Columbia River. Local stakeholders and interest groups have expressed an interest in a ped/bike crossing for many years.

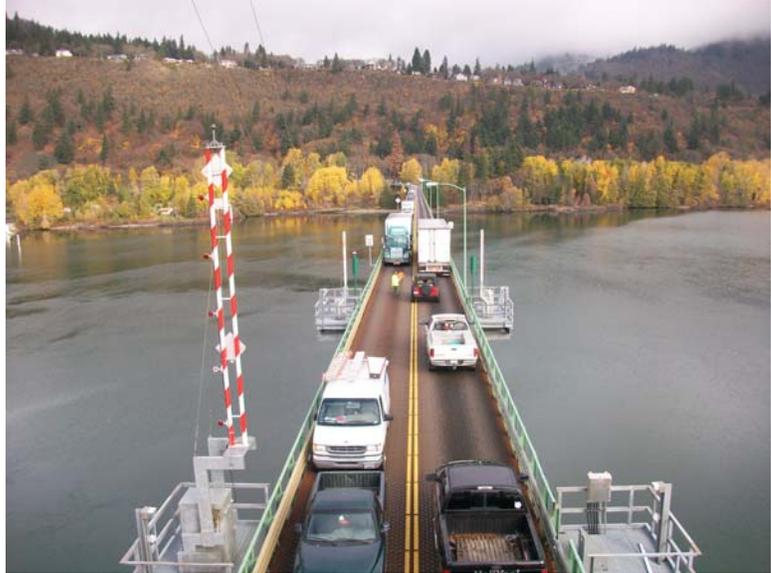
Figure 2. Extremely narrow bridge roadway and steel open grid deck are unsafe for ped/bikes

It is equally important to emphasize that it is not safe for pedestrians or bicyclists to cross the bridge. The lanes and distance between bridge rails is so narrow that vehicles often rub up against the bridge rail to avoid on-coming traffic causing vehicle and bridge damage. Vehicles often have mirrors knocked off from contact with the ancillary items (signs, gates, light posts, etc.) as seen in Figure 2 as well as the lift span truss.

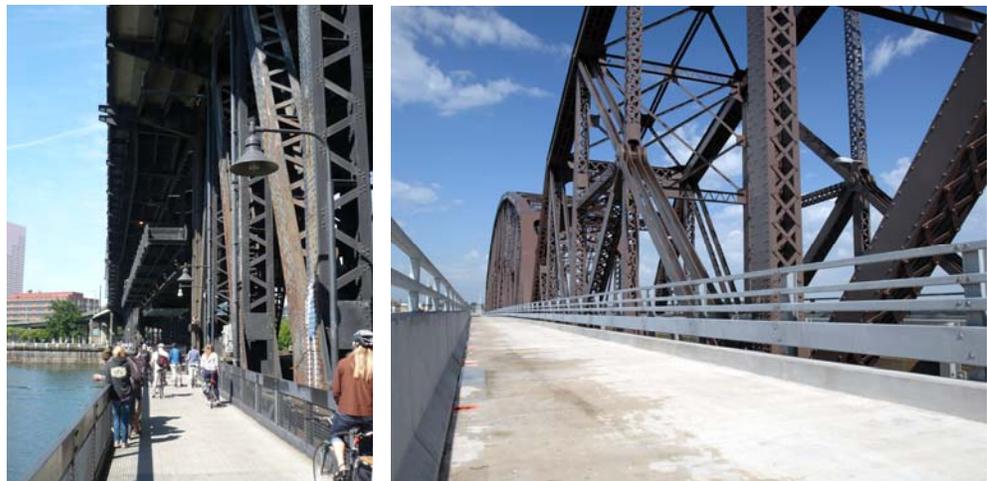
Figure 3. Example HNTB steel truss bridge widening projects with added ped/bike facilities [a] UPRR Steel Bridge, Portland, Oregon [b] McKinley Bridge, East St. Louis, Illinois.

HNTB considered four basic configurations for adding ped/bike facilities to the existing bridge. A brief description and comparison of these concept alternatives is listed in Table 1 below. Alternative 1 is similar to the work shown in Figure 3 below. This type of project has been successfully executed on steel trusses that have reserve structural capacity. Trusses that were designed for railroad loads, but later converted to vehicular loads have been successfully retrofit to carry ped/bike structural additions. Trusses that were once used for vehicular loads have been successfully converted to exclusive ped/bike use.

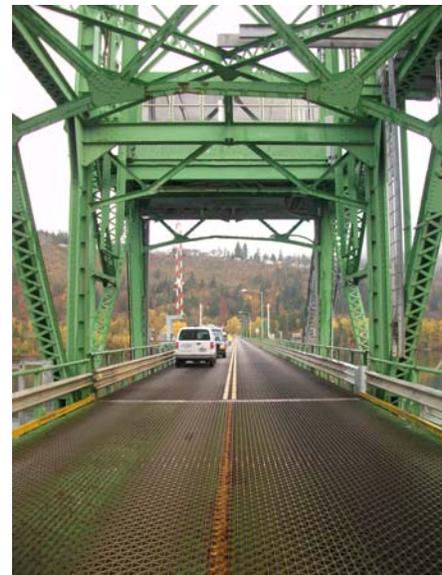
Figure 4. North lift span portal and tower with control house as viewed from lift span roadway.

The lift span of the bridge presents a number of issues when considering adding ped/bike facilities on the bridge. In particular, the lift span steel through-truss and lift span towers are in direct conflict with where ped/bike facilities would typically be located. To avoid the truss and towers a structure would have to be added out-board of the truss and weave around the towers. Furthermore, the access stairs to the lift span control house would have to be avoided.

Of more significance are the limitations and modifications of the lift span balance. The electrical, mechanical, and structural components that operate the lift of the bridge would need to be replaced to lift the added weight of the ped/bike structure attached to one side of the truss. Given that the structure would be added to one side of the truss a significant amount of weight would have to be added to the opposite side of the truss to balance the span during lifting. This added weight on both sides is very likely more than the lift span truss can hold. An alternate concept would be to hang a structure

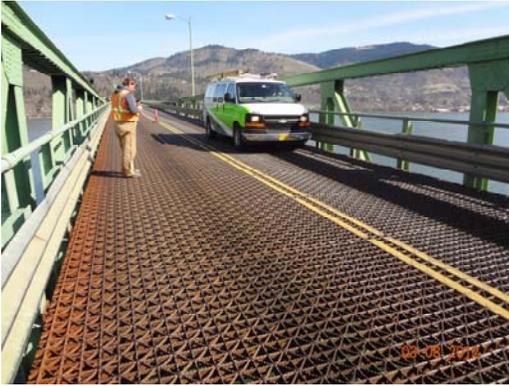
Figure 5. Oregon Spans 1-3 partial through trusses.

On the Oregon side of the bridge there are three unique spans of the bridge that are partial “through-trusses” as shown in Figure 5. These partial through-trusses have steel truss superstructure above the roadway surface that cannot be removed. In these spans it is assumed the pedestrian facilities are outboard of the partial through-trusses.
