**HOOD RIVER INTERSTATE BRIDGE
OVER THE COLUMBIA RIVER
HOOD RIVER, OREGON**

MECHANICAL AND ELECTRICAL INSPECTION REPORT

February, 2014

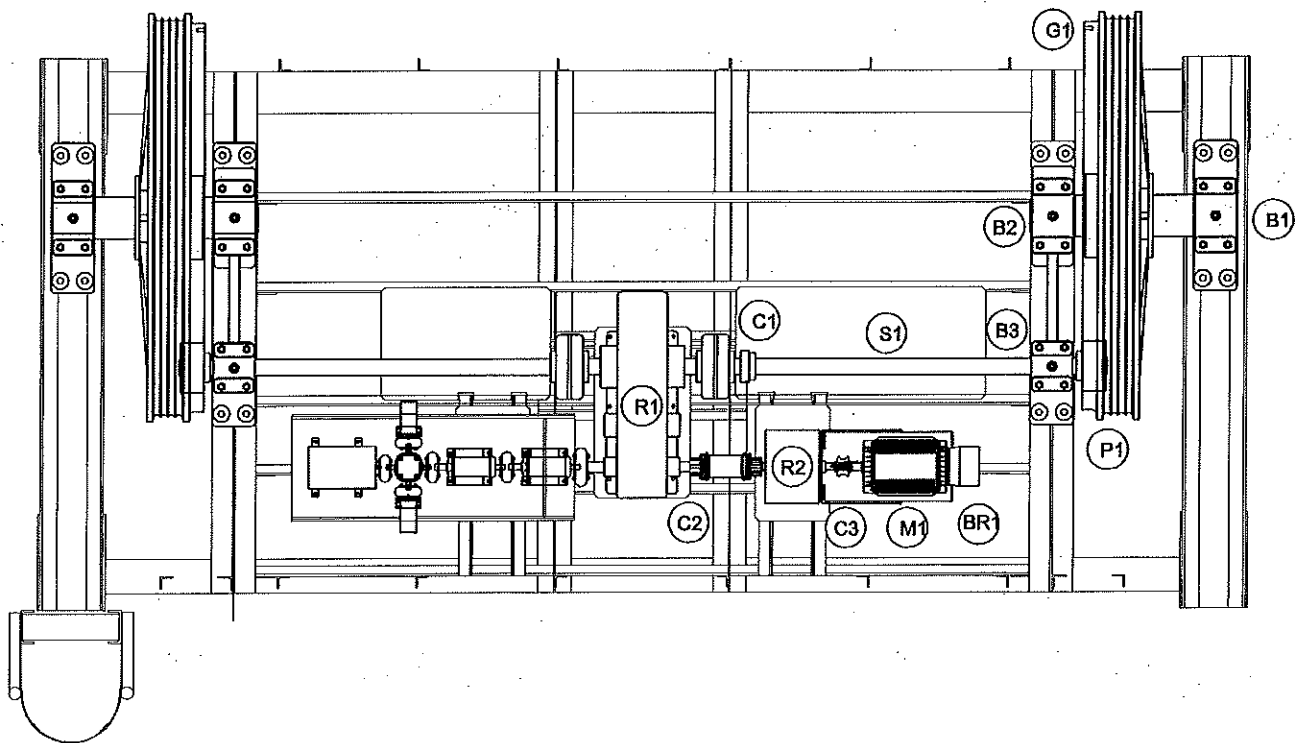
Figure 1 – Drive Machinery Layout – North Tower shown (South Tower opposite hand)

The tower driven vertical lift span is powered by machinery located at the top of each tower. Each tower has one 20/6.67hp, 1800/600 rpm, 2 speed, AC squirrel cage electric motor/reducer connected to a central reducer. The central reducer has two output shafts each connected to a pinion that drives an internal gear mounted to the counterweight rope sheaves causing the sheaves to rotate. Each sheave has four counterweight ropes connecting the lift span to the counterweights. As the sheaves turn, traction between the counterweight ropes and sheave moves the ropes which cause the bridge to raise and lower.

(see Figure 1 for the location of drive machinery components described below.)
